TECHNICAL NOTE

Digitally Captured Signature solution errors revealed by calibration and testing: Two examples

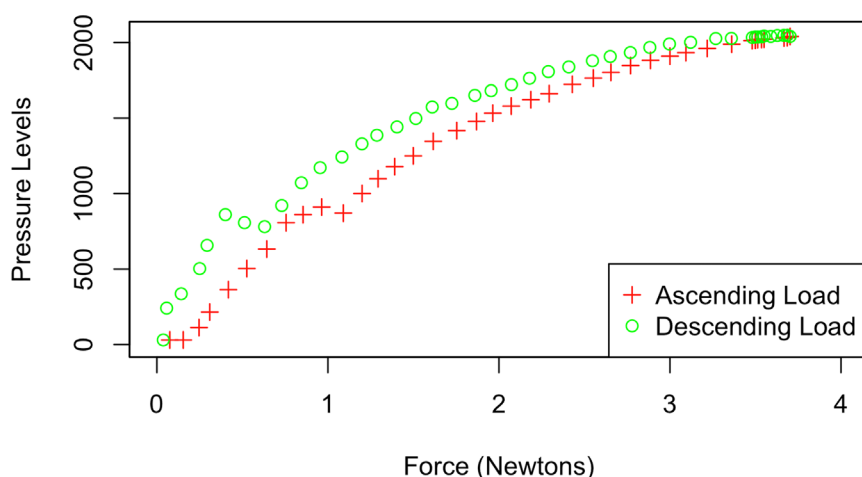
During calibration of the F Channel data, an error was detected; specifically when Force reached a specific value, a "anomaly" would appear in the assigned Pressure Level values (see Figure 1).

This is a serious problem because the same Pressure Level values are assigned to two different exercised force values, as observed in Figure 2 (e.g., for Pressure Level 700, there are two different Force values).

This error also affects the calculation of a Zeta Function for Hardware 1. DCS solutions provide the Force Channel data in arbitrary Pressure Levels; in order for those Pressure Levels to be comparable between different DCS solutions, it is necessary to calibrate the devices and calculate the Zeta Function, that is, the Function that calculates the assigned Pressure Levels from the exercised force, as described in the relevant literature [1]. From the Zeta Function, the inverse Zeta Function can then be calculated, which can provide the originally exercised force from the assigned Pressure Levels, thus normalizing the Force Channel data into Newtons. In this case, the assignment of the same Pressure Levels to more than one Force value renders the Zeta Function for Hardware 1 a non one-to-one function, which subsequently means that there can be no inverse Zeta Function calculated. Consequently, the assigned Pressure Levels cannot accurately be normalized into Force values in Newtons.

FIGURE 1 Hardware 1 calibration curve. It can be observed that both the ascending and descending load curves exhibit areas of abnormality (around the values of 1 N for the ascending and 0.7 N for the descending load), respectively.

The authors communicated these findings to the manufacturer of the hardware, and after a series of tests with the authors, the firmware of the digitizer was identified as the source of the error, and it was updated to accommodate for this error (see Figure 3).

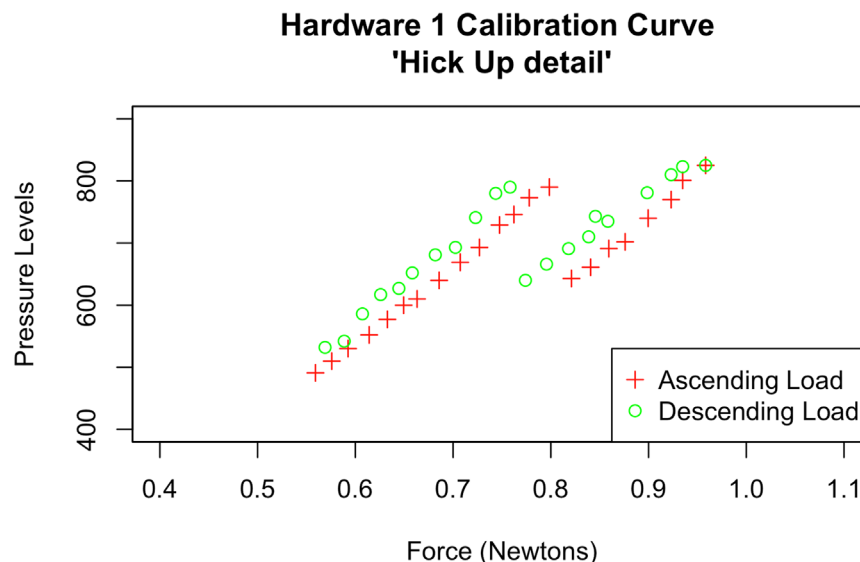
As can be seen in detail in Figure 2 and in the raw data in Table 1, there is a point in the ascending load calibration (Force=0.821 N) and a different point in the descending load calibration (Force=0.758 N) where a "anomaly" is observed. In the ascending load part, the assigned Pressure Level values fall from 790 for 0.798 N to 643 for 0.821 (when they should be only increasing), and for the descending load part, the assigned Pressure Level values jump from 640 for 0.774 N to 790 for 0.758 (when they should only be decreasing).

FIGURE 2 Detail of the “anomaly” section for both ascending and descending loads. These should be continuous lines following a pseudo-logarithmic rule.

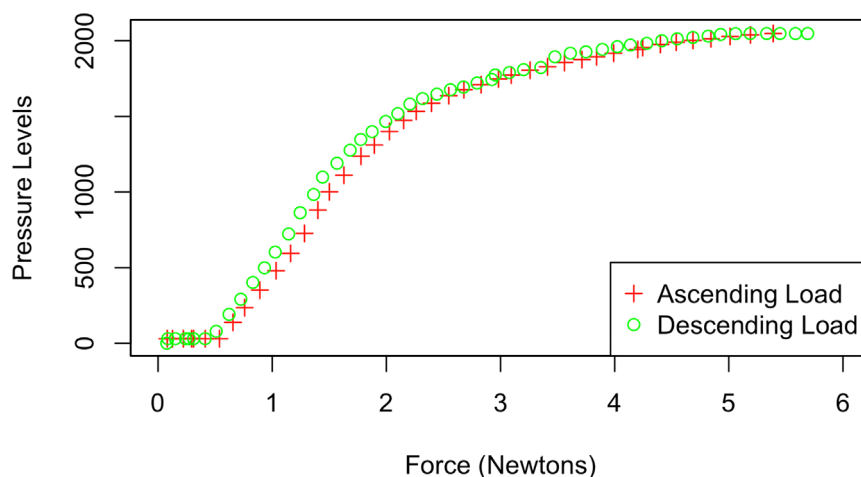
FIGURE 3 Calibration curve of Case 1 DCS solution, after the firmware update. No abnormalities can be observed.

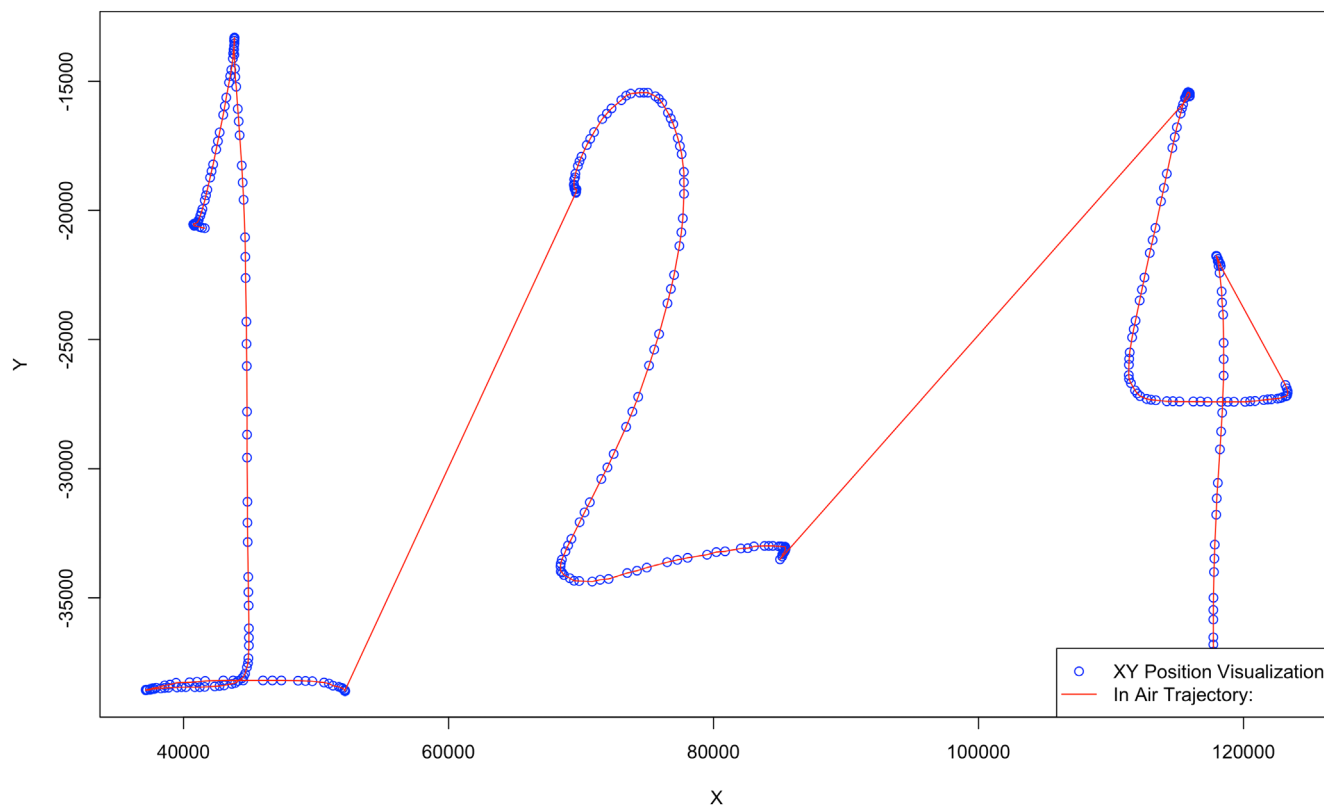
FIGURE 4 Presentation of test capturing on Samsung SM-P610 Galaxy S6 Lite through Software 2, and its stylus. The in-air movement of the stylus between the written numbers 1, 2, and 4 is not captured/visualized.

Testing and measurements that were conducted with Software 2 showed that the movement of the stylus on air (i.e., without the

tip of the stylus being in contact with the glass surface of the digitizer), a.k.a. In Air Trajectories (IATs) was not captured, even though the digitizer technology of the hardware is EMR and supports it (Table 3). Further testing of the same device with the application Namirial GraphoSign App proved that the device and its stylus were able to capture IATs; therefore, it was deduced that the source of the problem was the software.

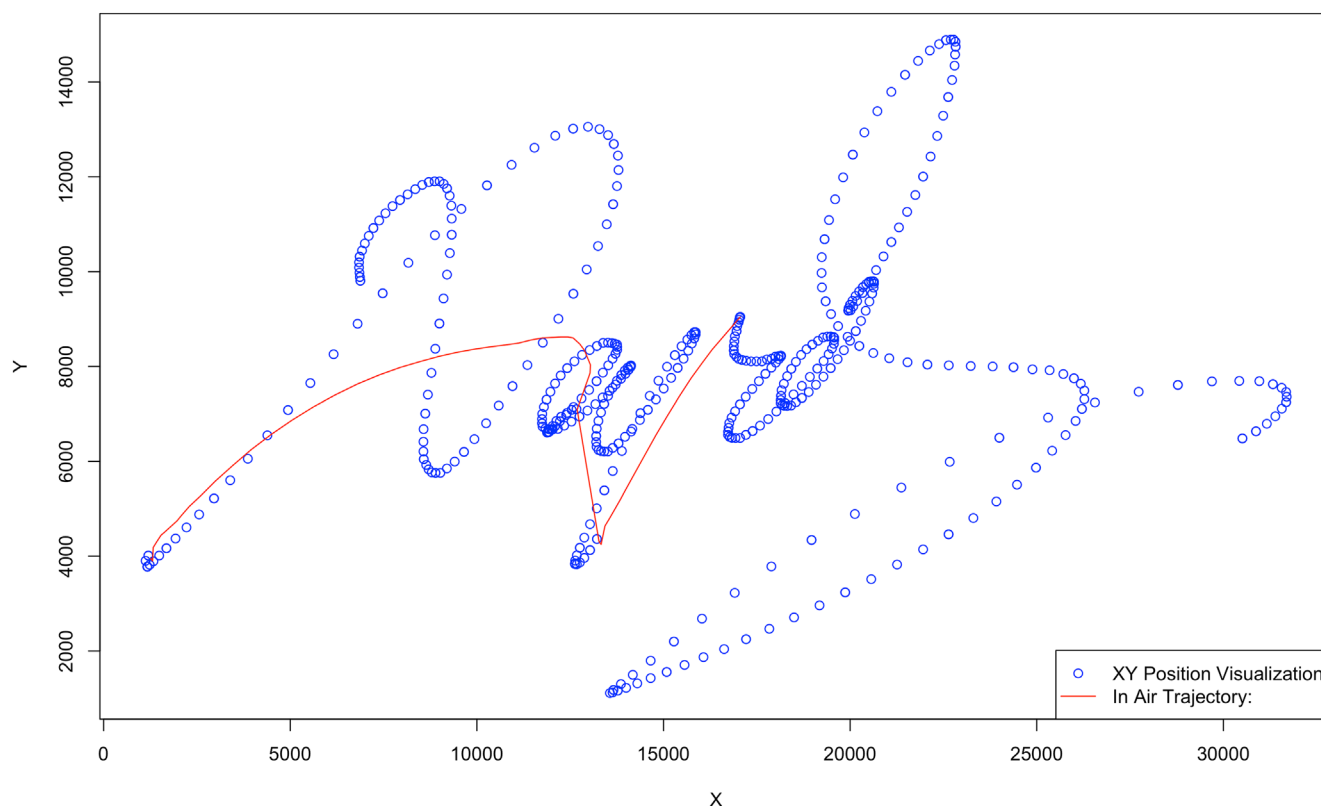
FIGURE 5 Presentation of test capturing on Samsung SM-P610 Galaxy S6 Lite through the Namirial Graphosign App, with its stylus. The capturing of the IAT of the stylus is presented in red color.

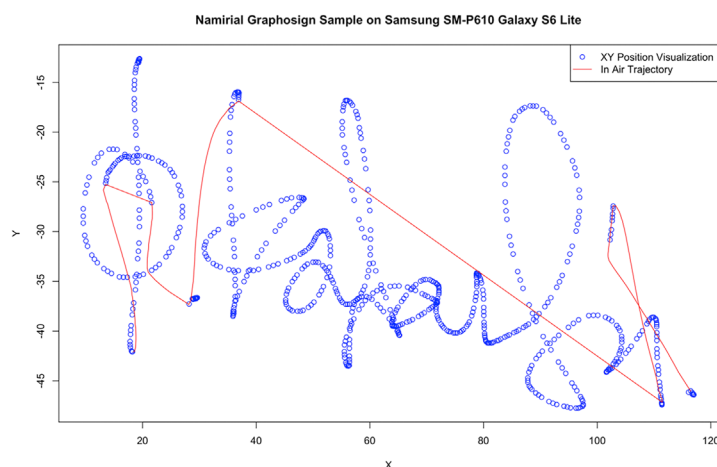
Presentation and visualization of a test DCS captured with Samsung SM-P610 Galaxy S6 Lite with Software 2 after the version update, with its stylus. The IAT of the stylus can be observed in red color.

FIGURE 6 Presentation of a DCS captured with Case 2 solution after the update. Both the XY plot and the (part of the) raw data show the recording of the pen position (XY) when in air (P=0).

IATs should be captured (Figure 6). These findings were communicated to the software manufacturer and the error was corrected in a subsequent version update of Software 2.

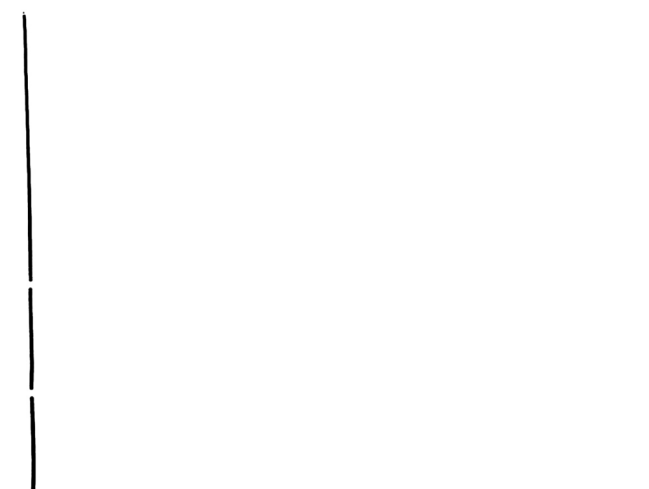
Figure 7 depicts the visualization of a straight line executed in one stroke, that is, without lifting the tip of the stylus from the glass surface of the digitizer, as captured with Software 2 on Samsung SM-P610 Galaxy S6 Lite with its stylus. It can be observed that the segments appear as if without contact with the tip of the stylus. This artifact constitutes a big problem as the motion of the stylus during the execution of the signature movement is not faithfully captured

FIGURE 7 Visualization of a continuous line (in one stroke) that was captured and represented with breaks due to slow speed of execution, captured with Software 2.

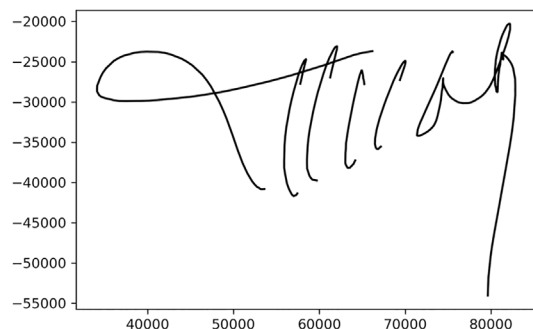
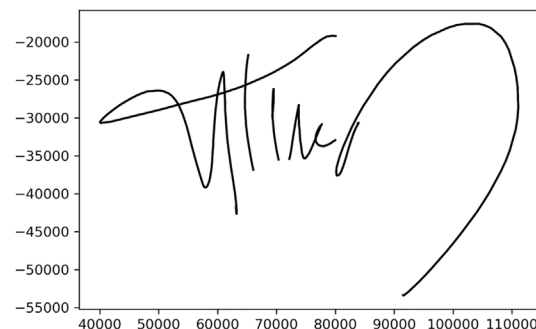
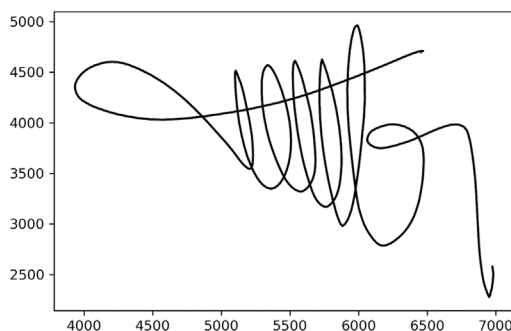
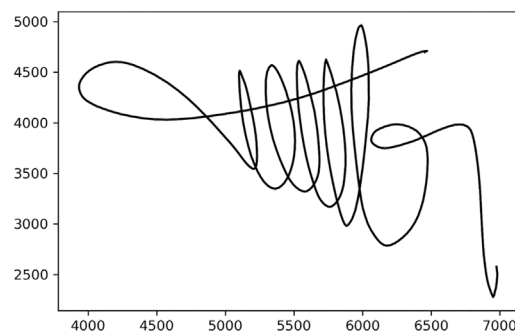
FIGURE 8 Examples of the error 2 of case 2 deployment. On the top row, two sample signatures captured with the problematic software are visualized in XY plots; on the bottom row, two sample signatures of the same writer captured with another DCS solution that has no errors. Discontinuity in the execution of the top row signatures can be observed in comparison with the bottom row continuous (one stroke) samples.

As observed in Figure 8, two signatures of the same writer exhibit the discontinuity and appear as if executed in 5 and 6 strokes, respectively. This behavior is differentiated from the normal behavior of the writer who executes their normal signature in one stroke only, as can be observed from samples

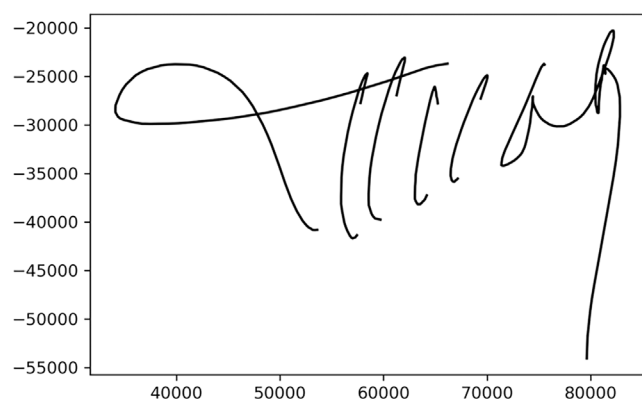
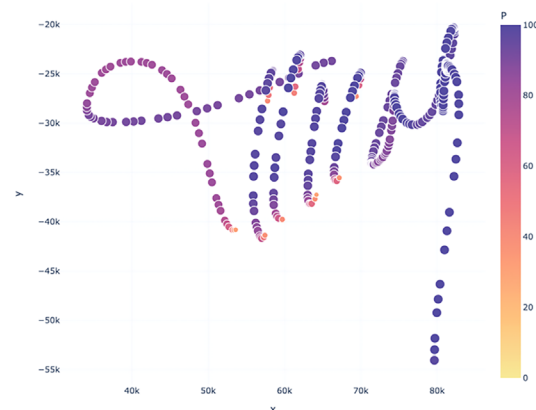
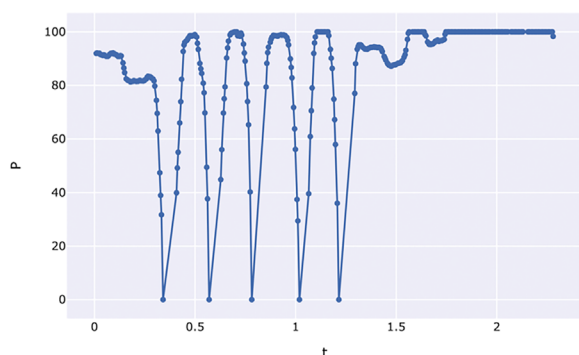
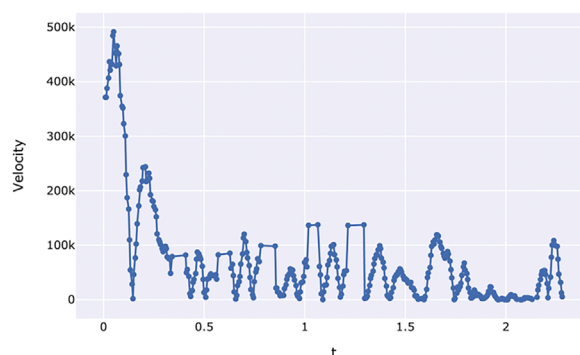
FIGURE 9 Visualization of the first sample signature with the problematic software. The missing data can be observed in the various representations.

As can be observed on Figures 9 and 10, this solution not only does not record events whilst the stylus is slowing down, but also introduces zero Force artifacts in the data, creating the illusion of change of stroke number—which explains the large temporal gaps in

the data. Apparently, Software 2 considers the stylus to have been removed from the active area and stops recording its positions.

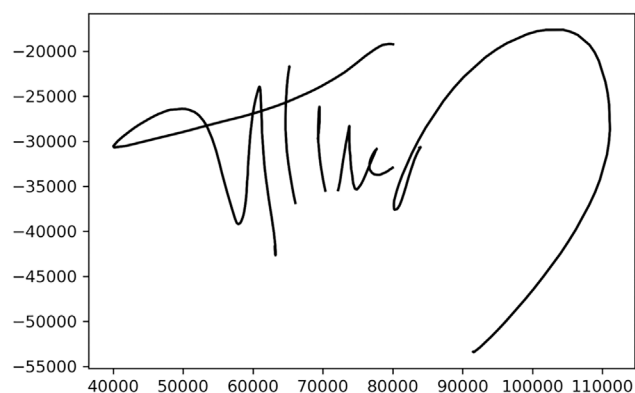
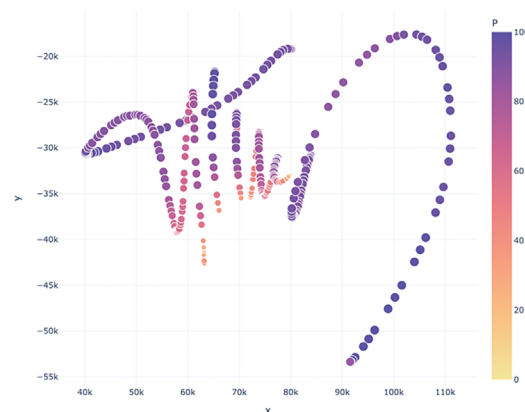
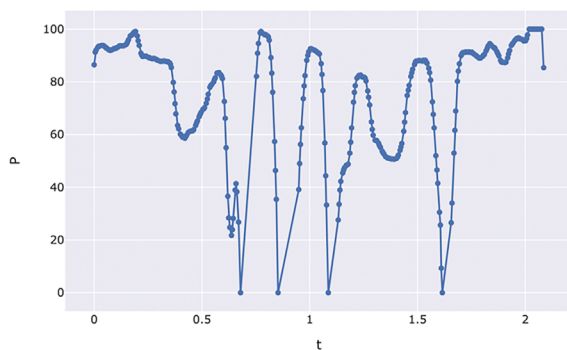
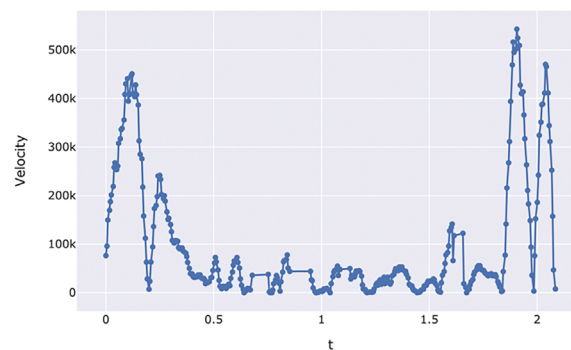
FIGURE 10 Visualization of the second sample signature with the problematic software. The missing data can be observed in the various representations.

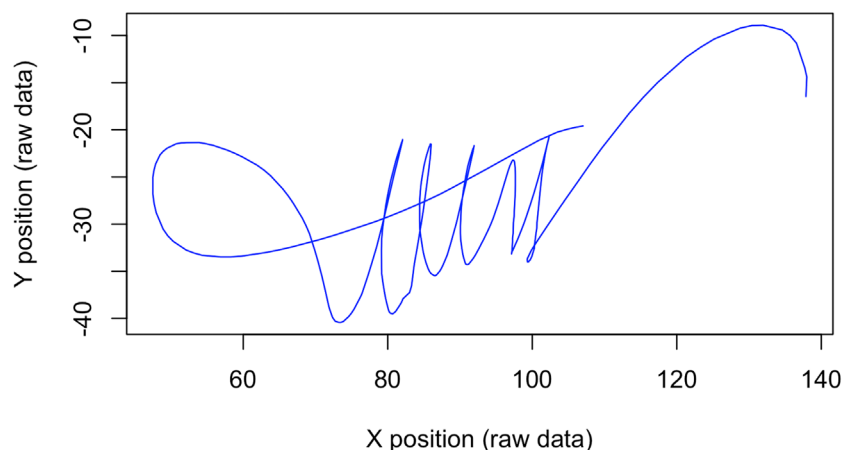
FIGURE 11 Signature captured with the updated version of Software 2—no discontinuity observed.

To determine the source of the problem, testing was carried out with software from a different manufacturer, and specifically App Graphosign, and this error was not observed. This finding pinpoints the source of the error to Software 2. This defect was also communicated to the software manufacturer and was corrected with the subsequent version of the app (see Figures 11 and 12).

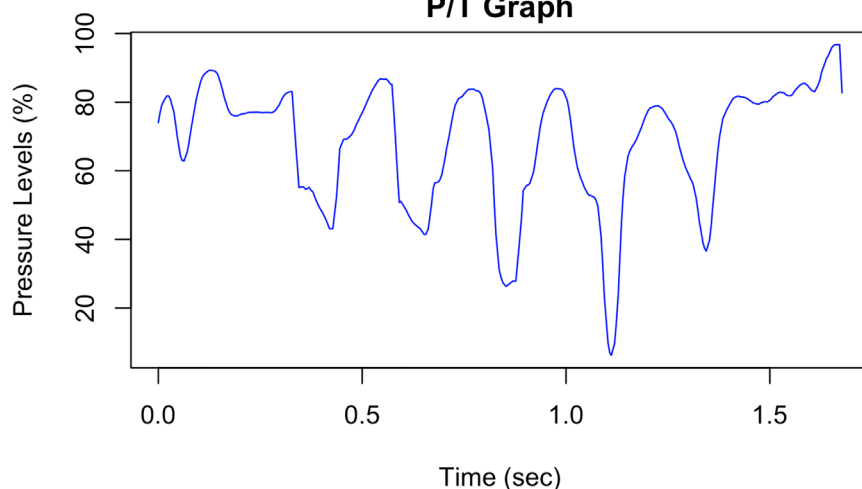
FIGURE 12 P/T Time Graph of signature from Figure 11—no discontinuity observed.
