TECHNICAL NOTE

Digitally Captured Signature solution errors revealed by calibration and testing: Two examples

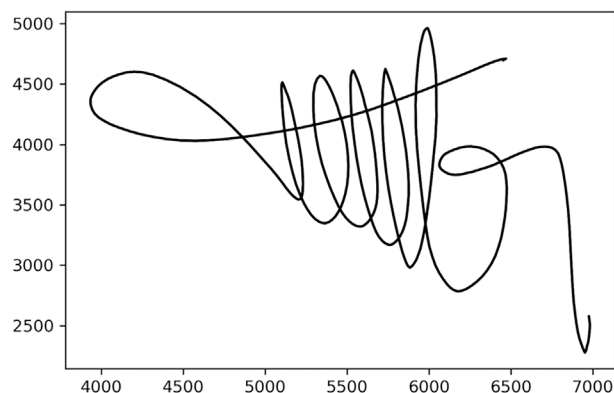
Connected Line
Visualization –
Reference Sample
(STU530)

FIGURE 13 Visualization of one of the sample signatures of the same writer, with a properly functioning DCS solution.
